## Toner Alert Messages on the Katun Arivia MFP's

**Date:** July 2026

**Applicable Models:** All Arivia MFP's

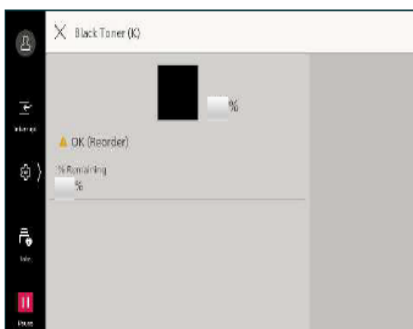
#### 1.Pre-Near Empty

### 1. Reorder (Toner Cartridge)

- **Indication:** Toner level has reached a preliminary threshold (often around 10-20% remaining, depending on usage and settings).
- **Impact on Operation:** Printing continues normally. Print quality is unaffected at this stage.
- **Recommended Action:**
  - Order replacement toner cartridges proactively.
  - Monitor usage; consider shaking the cartridge gently (if safe per guidelines) to redistribute toner for extended life.
  - Check remaining levels via the Device menu or status screen.
- **Tip:** This is a proactive alert—do not ignore it, especially in high-volume environments.

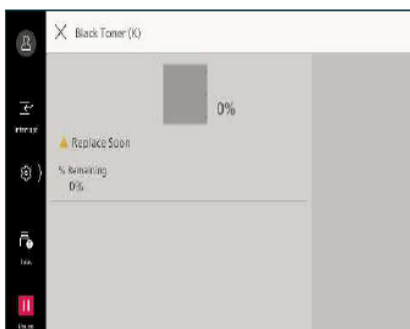
#### 2.Near Empty

### 2. Replace Soon (or equivalent to "Near Empty" / "Replace Soon")

- **Indication:** Toner is low (typically <10% or nearing exhaustion).
- **Impact on Operation:** Printing usually continues, but faint prints, streaks, or color inconsistencies may begin to appear.
- **Recommended Action:**
  - Do Not Replace the affected cartridge(s) when the “Replace Toner” notification appears.
  - Have spares on hand.
  - If quality degrades, stop large jobs and replace them immediately.
- **Note:** Continuing to print extensively at this stage risks poor output and potential waste of media.

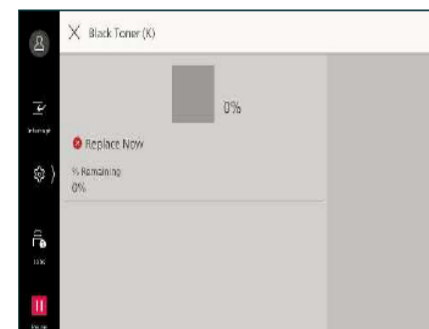
#### 3.Empty

### 3. Replace Now (Empty)

- **Indication:** Toner cartridge is empty or below usable threshold.
- **Impact on Operation:** The machine may stop accepting print/copy jobs for the affected color (or all jobs in strict modes).

- **Recommended Action:**

- Open the front cover, remove the empty cartridge, and install a new one following the user manual instructions.
- Dispose of/recycle the used cartridge.
- After replacement, the machine will reset the toner level automatically. Run a test print to verify.
